ENVIRONMENTAL ASSESSMENT

APPENDIX E: RED FLAG INVESTIGATION AND HAZARDOUS MATERIALS

Re: RED FLAG INVESTIGATION
Des. Nos. 1592385 & 1600808
Interchange Reconstruction
I-65/I-70 North Split
Marion County, Indiana

I-65 / I-70 NORTH SPLIT
INDIANAPOLIS, MARION COUNTY, INDIANA
INDOT DES #1600808

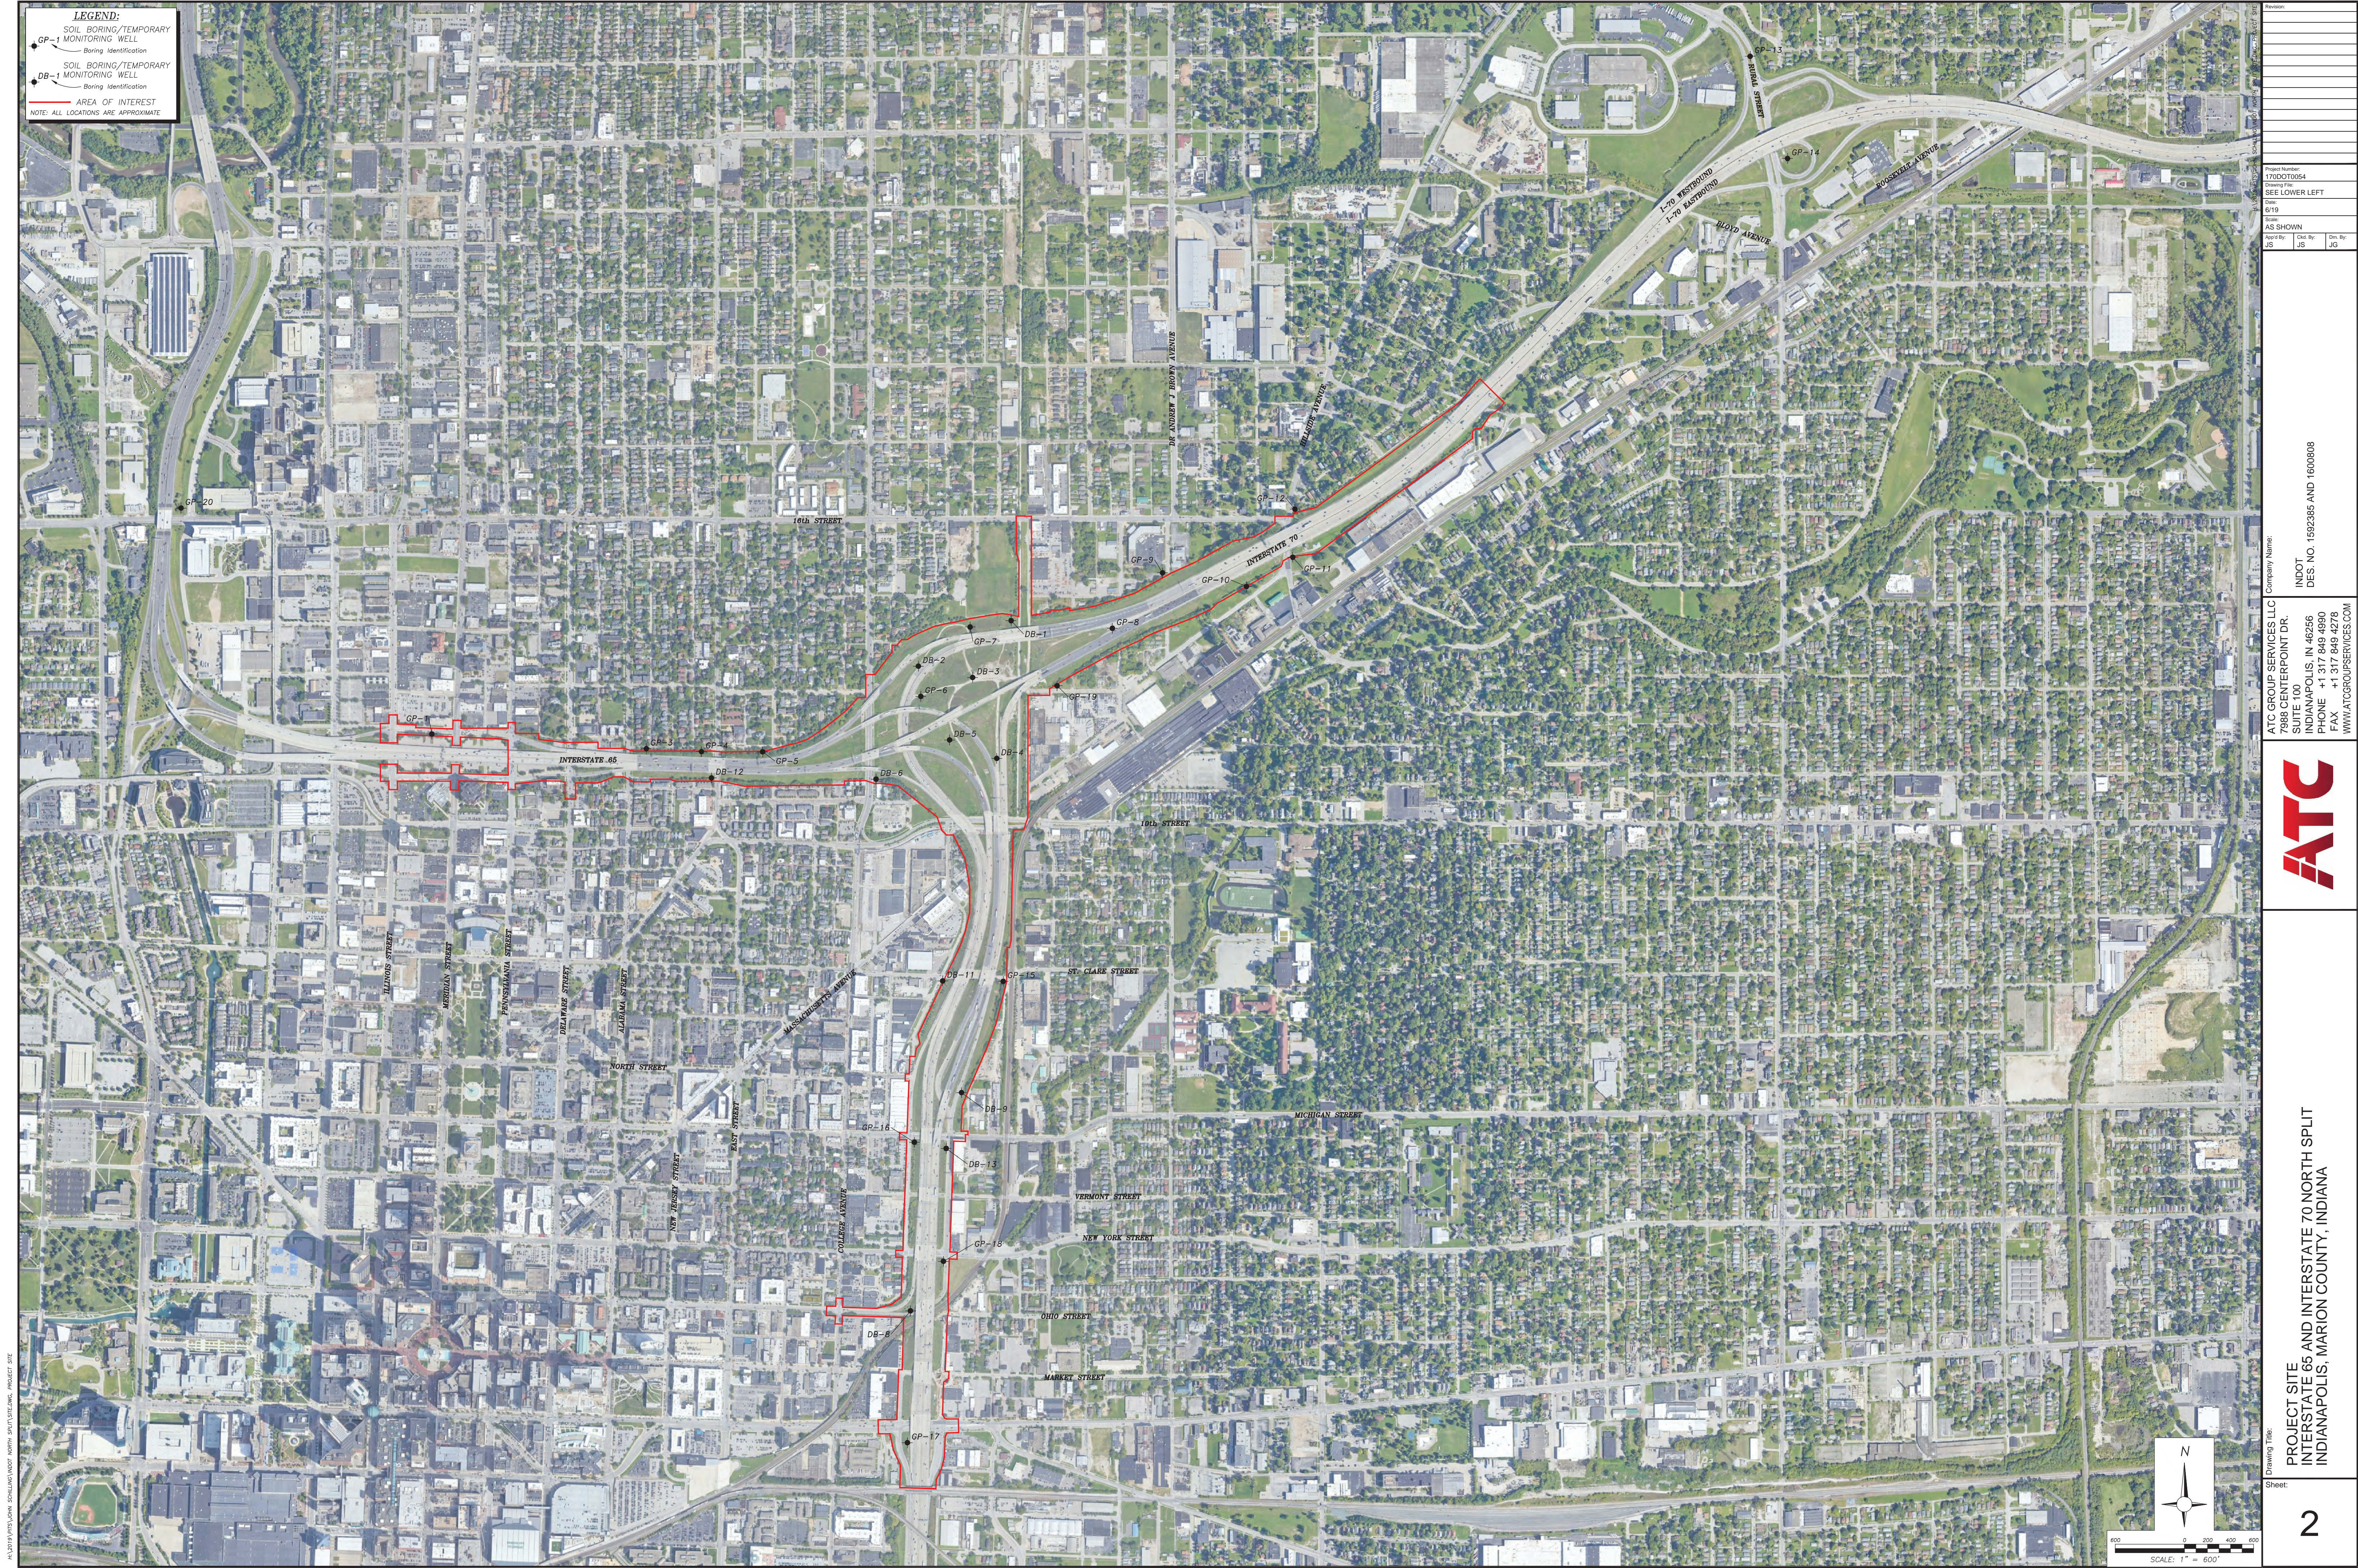
LEGEND:
SOIL BORING/TEMPORARY
GP-1 MONITORING WELL
Boring Identification
SOIL BORING/TEMPORARY
DB-1 MONITORING WELL
Boring Identification
AREA OF INTEREST
NOTE: ALL LOCATIONS ARE APPROXIMATE
