Waters of the U.S. Report

I-65/I-70 North Split Interchange Reconstruction

Marion County, Indiana

Designation No. 1592385 (Lead), Contract No. 36910

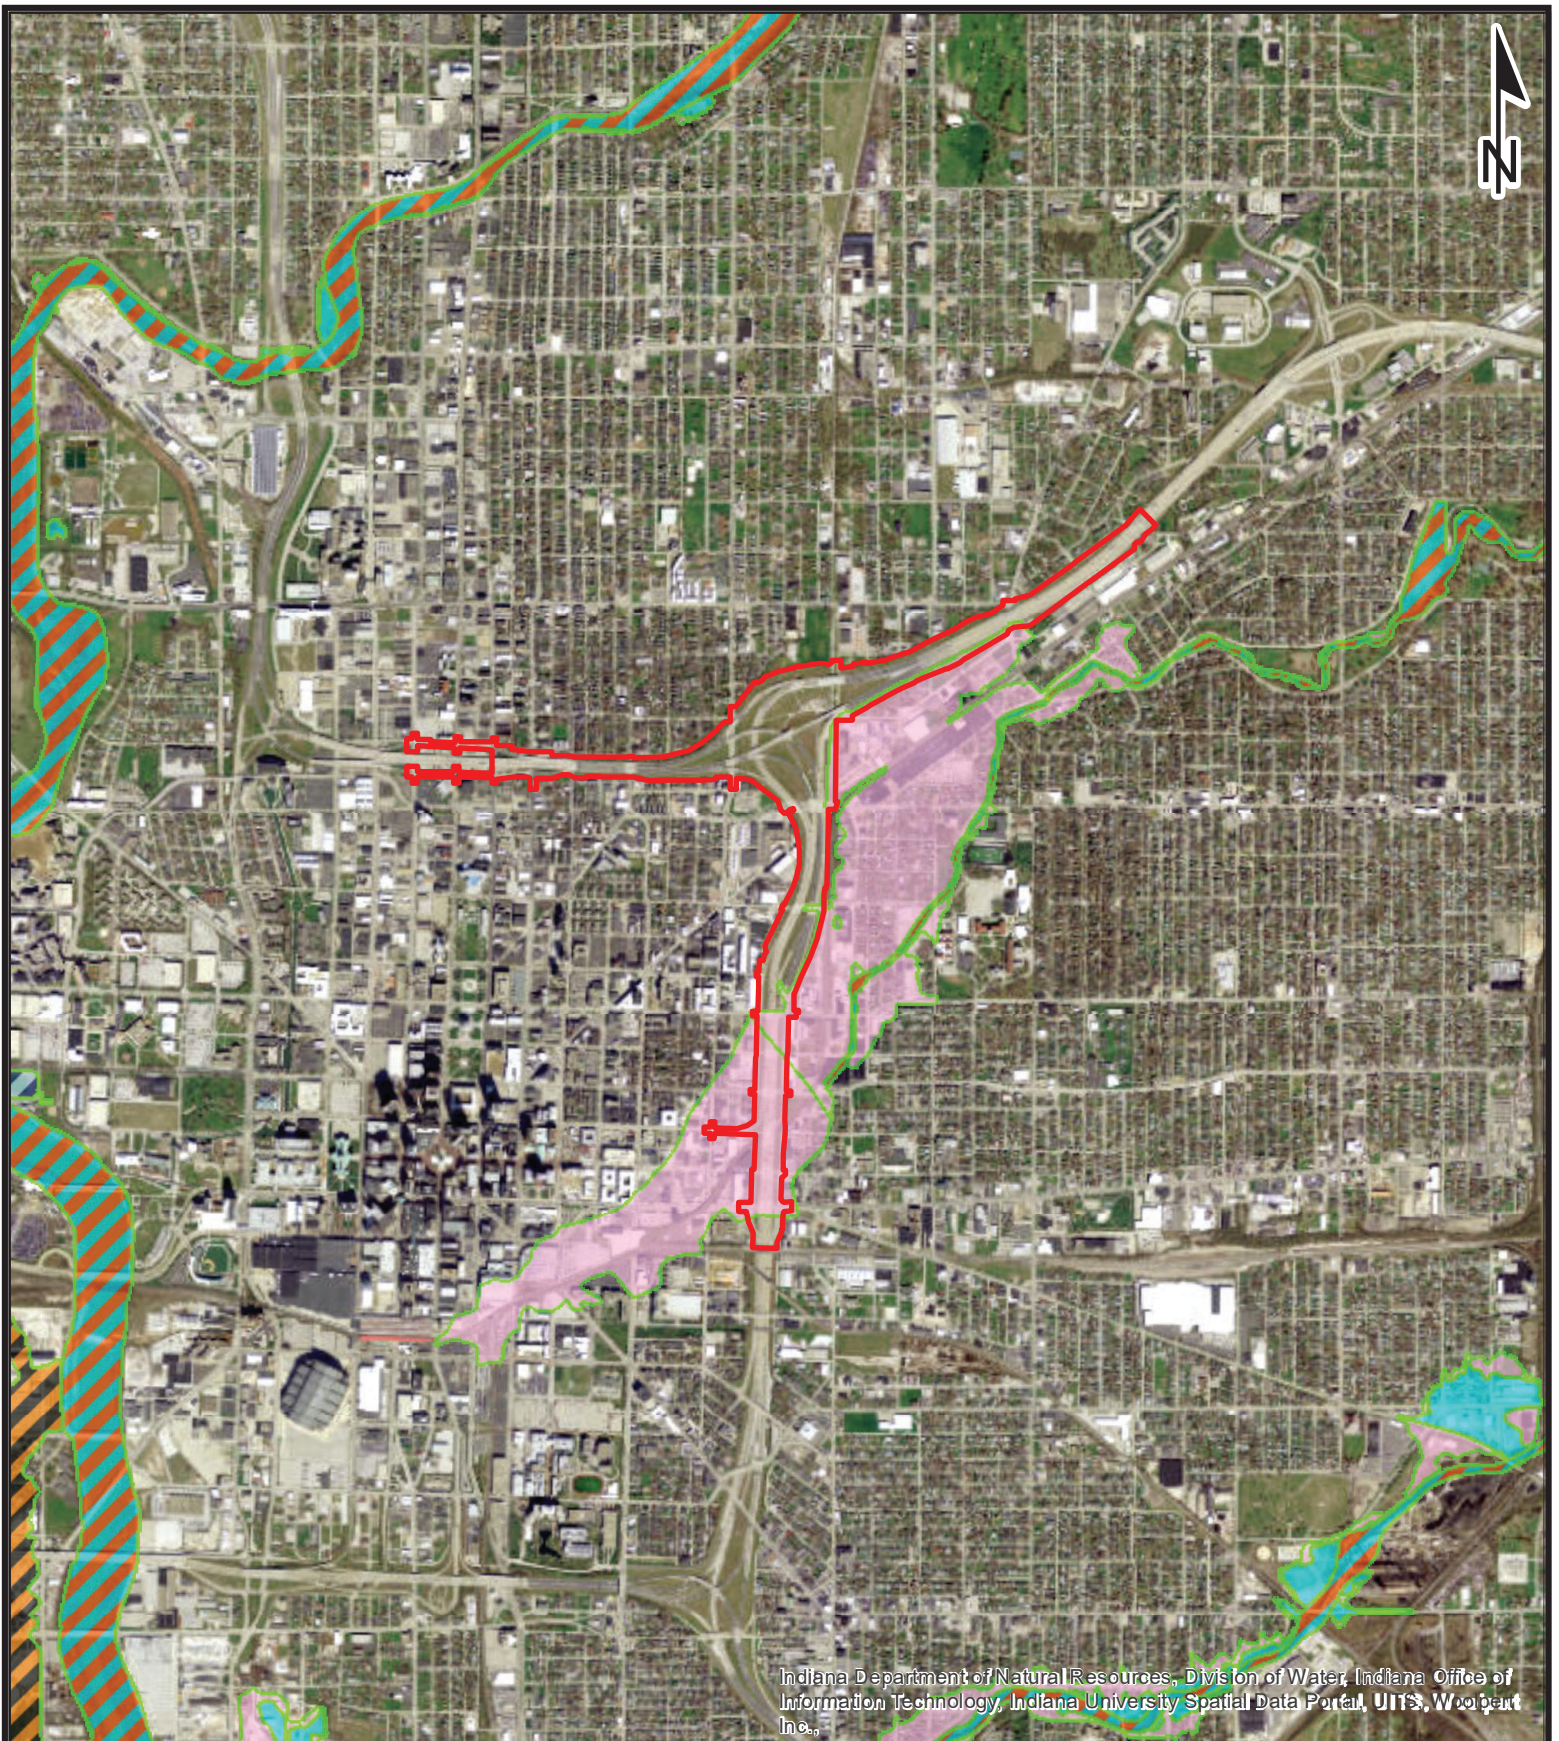
IDNR Floodplain Map

Best Available Flood Hazard Layer
